**RE:** File No. 7202 –Kennedy Longfellow Roof Replacement - Addendum No. 1

Kennedy Longfellow School

Roof Replacement Project

General Roofing conditions.

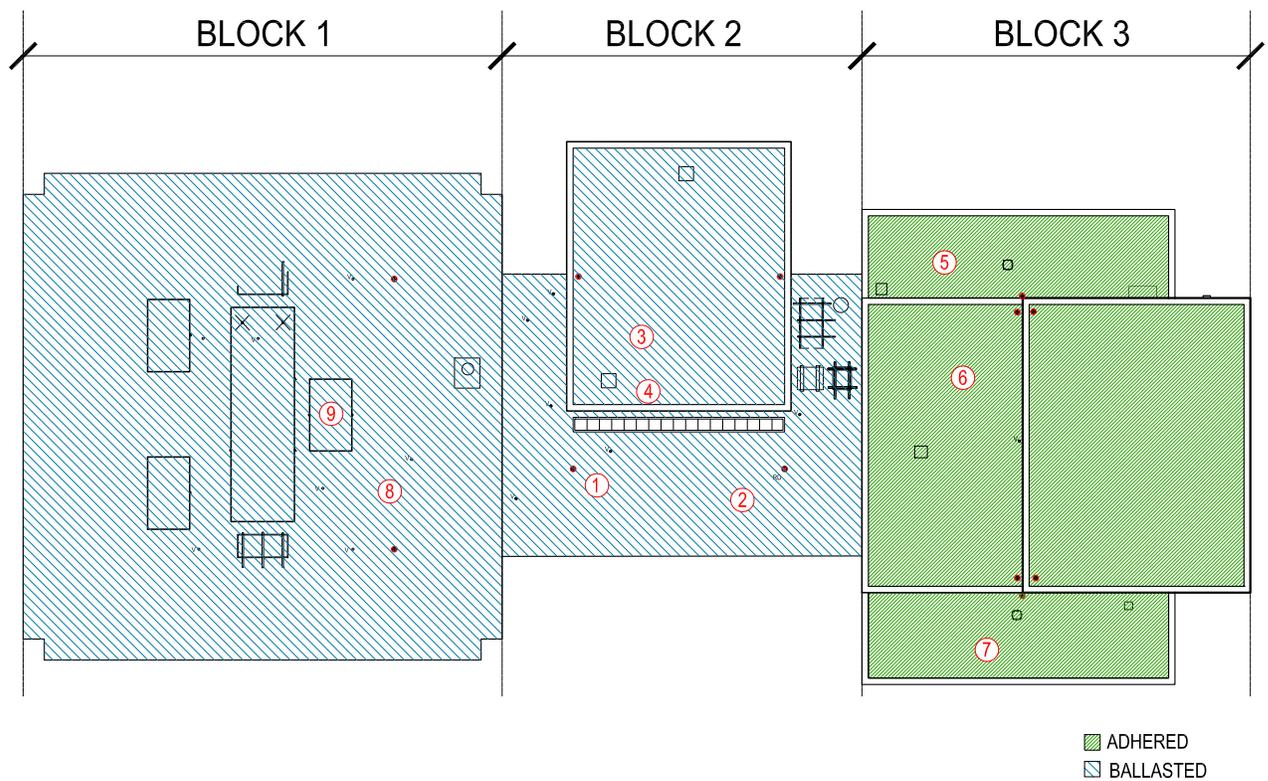
ROOF TEST CUT LOCATIONS

9 Test Cuts were performed to examine the roofing build up which revealed varied roofing assemblies through out the area. Roof 1 and 2 are gravel ballasted with a 4 ply asphalt roofing membrane, 1/2" hard board on top of 2" fiberboard insulation, with some areas patched with a ballasted EPDM membrane system, Roofs 4,5,6,7 is mechanically fastened EPDM, 1/2" fiberboard, 3" Iso insulation. Roof 8,9,10,11,12 is stone ballasted EPDM membrane, 1/2" fiberboard on 3 1/2" rigid insulation. 8 of the 9 test cuts revealed wet insulation below the membrane.

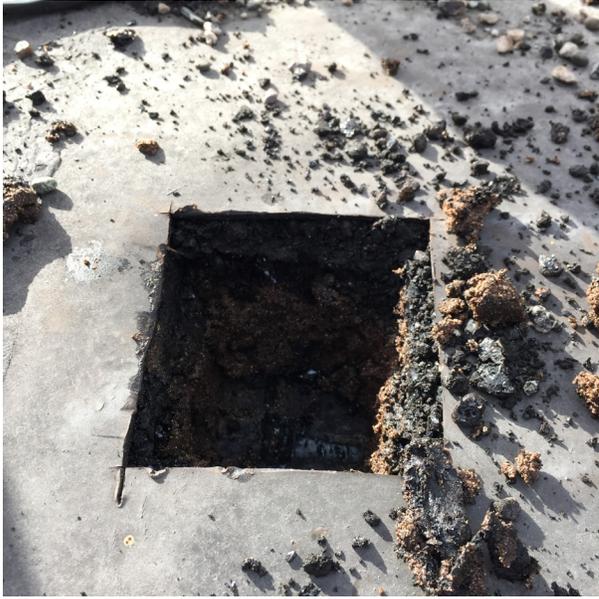
Test cut #1

Ballasted roof, membrane with 1/2" hard board on top of 2" fiber board on top 1/2" of tar and gravel. Insulation wet

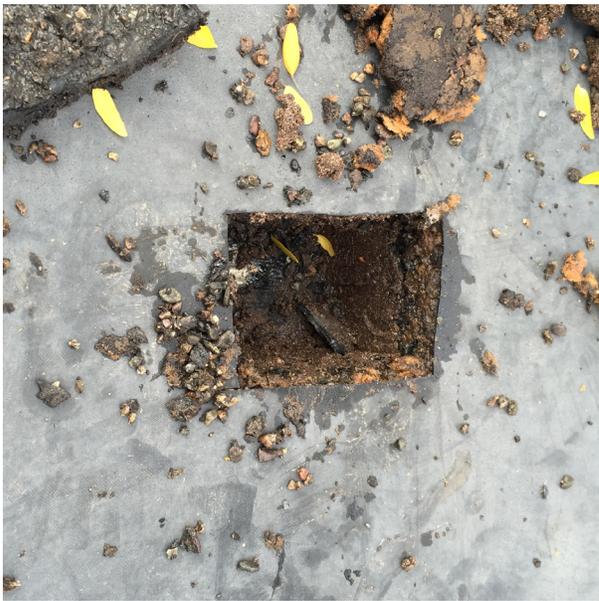
Test cut #2

Ballasted roof, membrane with 1/2" hard board on top of 2" fiber board on top 1/2" of tar and gravel. Insulation wet

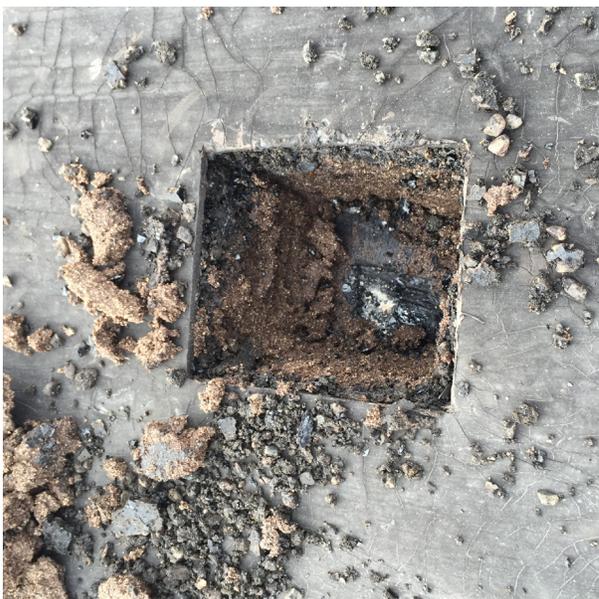
Test cut #3

Ballasted roof, membrane with 1/2" hard board on top of 2" fiber board on top 1/2" of tar and gravel. Insulation wet

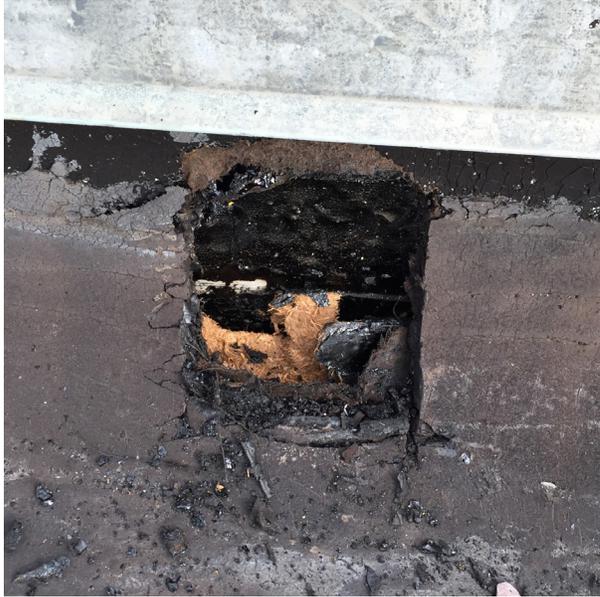
Test cut #4

Ballasted roof, membrane with 1/2" hard board on top of 2" fiber board on top 1/2" of tar and gravel. Insulation wet

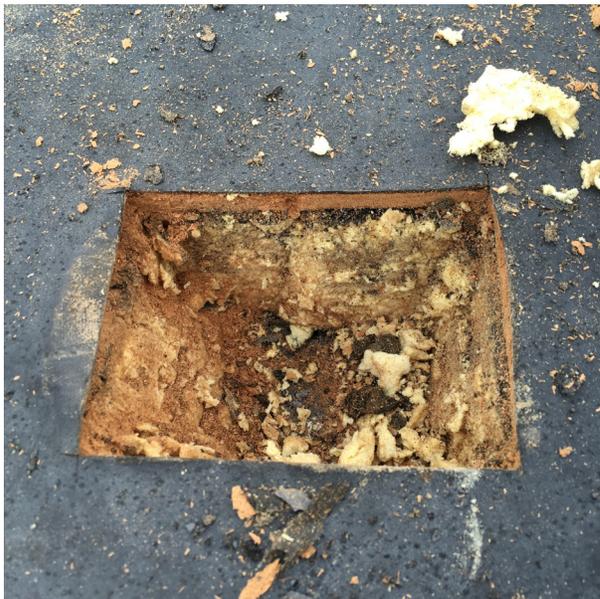
Test cut #5

Fully adhered roof, membrane with 1/2" fiberboard on top of 3-1/2" ISO adhered with tar. Insulation wet

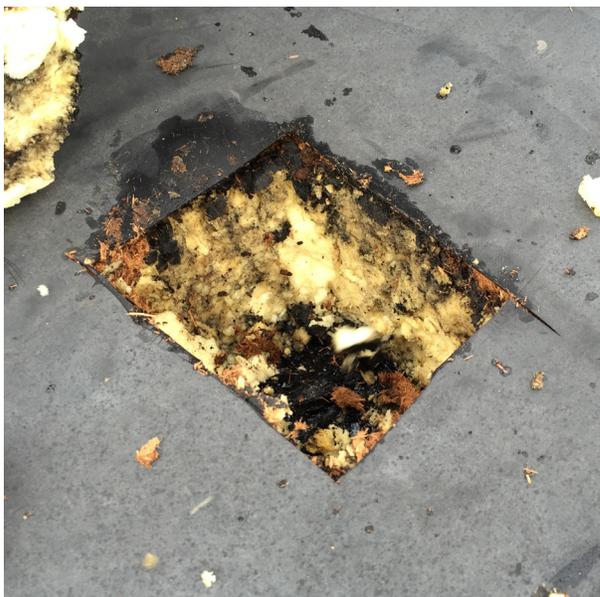
Test cut #6

Fully adhered roof, membrane with 1/2" fiberboard on top of 3-1/2" ISO adhered with tar. Insulation wet

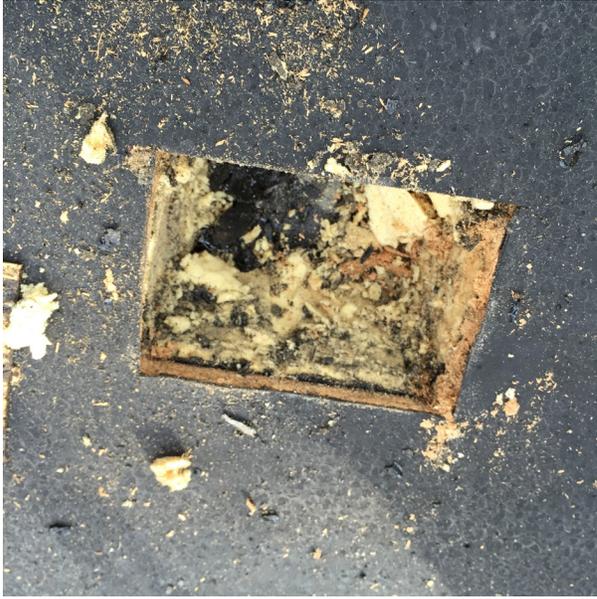
Test cut #7

Fully adhered roof, membrane with 1/2" fiberboard on top of 3-1/2" ISO adhered with tar. Insulation dry

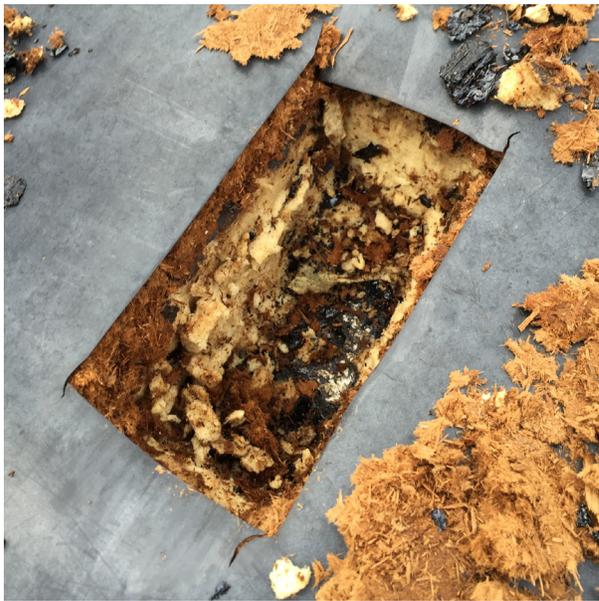
Test cut #8

Ballasted roof, membrane with 1/2" fiberboard on top of 3-1/2" ISO adhered with tar. Insulation wet

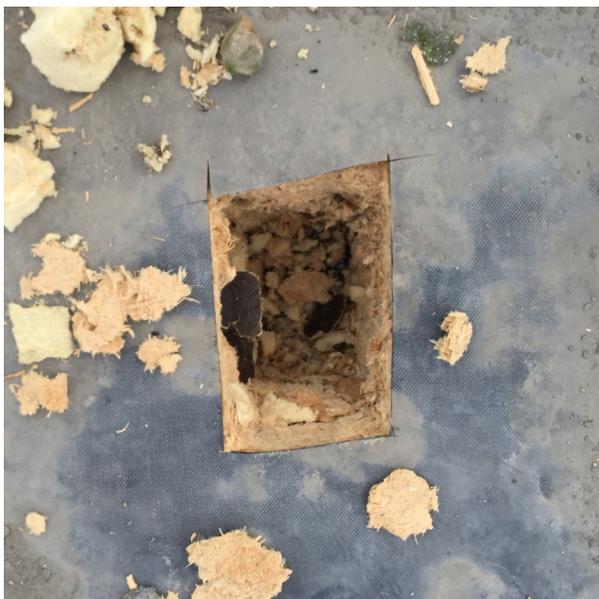
Test cut #9

Ballasted roof, membrane with 1/2" fiberboard on top of 3-1/2" ISO adhered with tar. Insulation wet
