MEMORANDUM

Re: Awaiting Order 14-128 Crosswalk at Cadbury Commons on Sherman Street

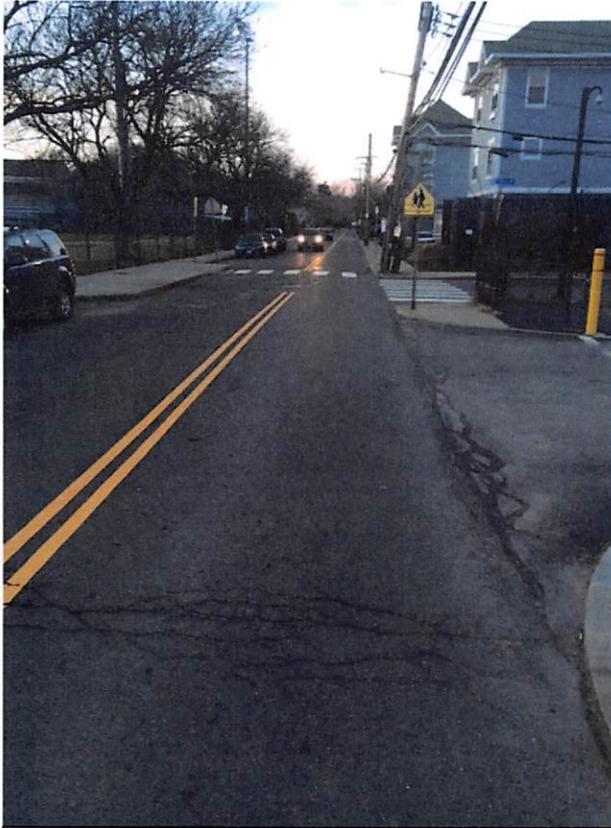
Looking north on Sherman Street, Cadbury Street and Cadbury Commons are on the right

At Cadbury Street, both sets crosswalk markings are in good condition and a school crossing sign is present on Sherman Street on both approaches. In addition, the curb extension on the west side of Sherman Street improves the sight lines from that end and reduces the crossing distance for pedestrians. The crosswalk across Sherman Street in this location is 20 feet long, or about 7 paces.

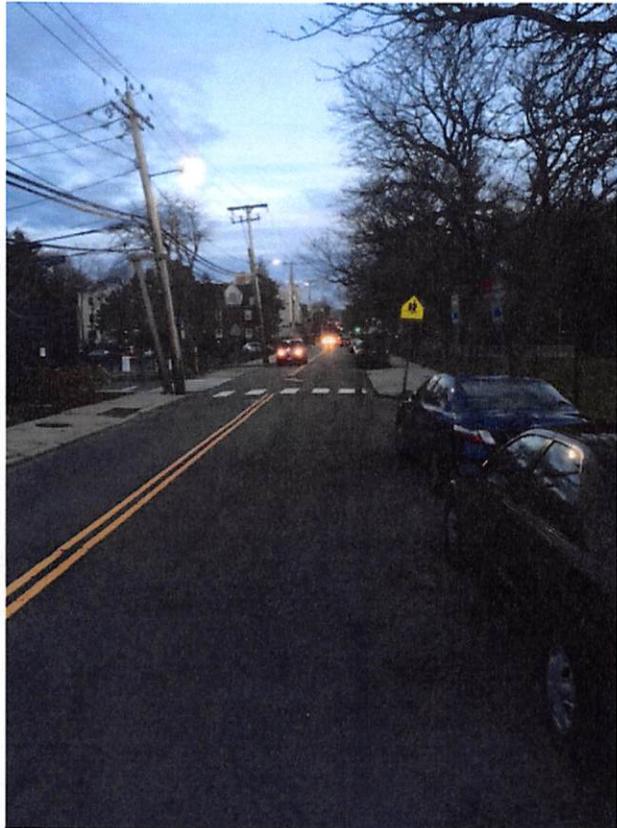
Looking south on Sherman Street, Cadbury Commons is on the left

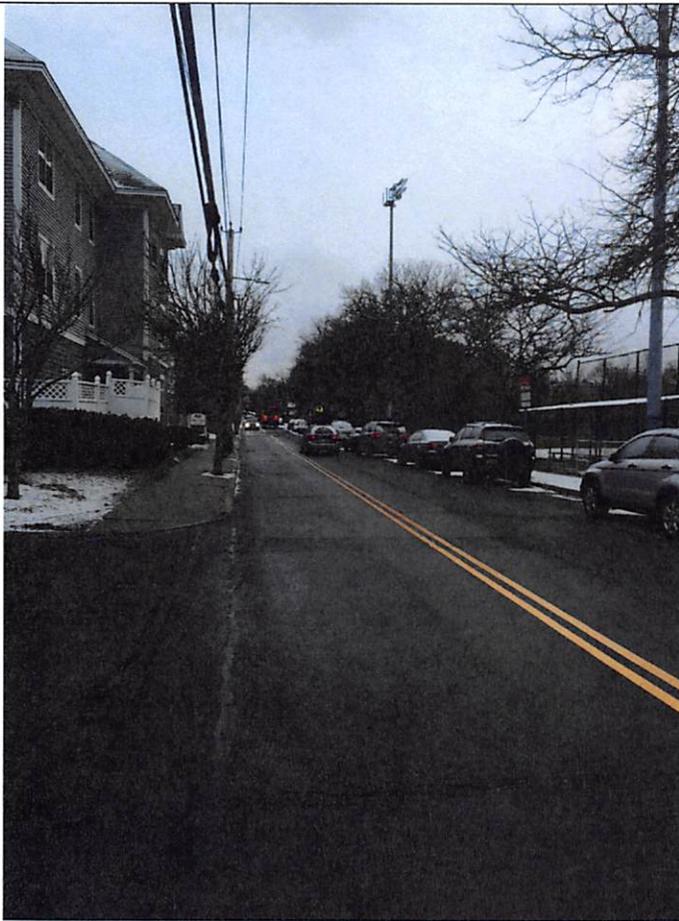
At the crossing closer to St. Peter's field, the crosswalk markings are also in good condition. A view from the crosswalk is shown below. Visibility is very good in both directions.

Looking south. Cadbury Commons is on the left.

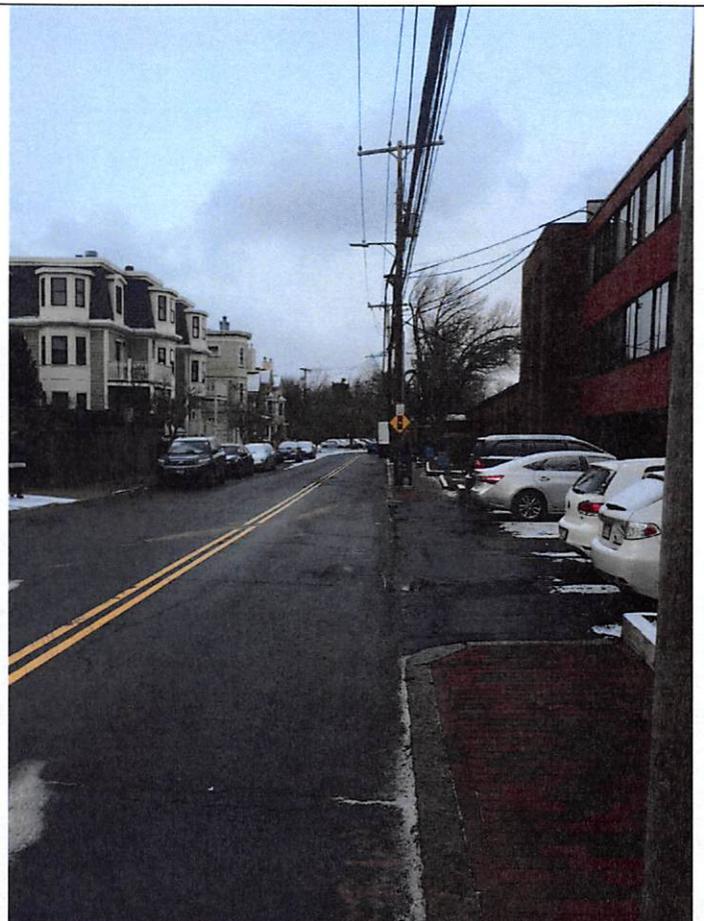
Looking north. Despite the curve in the road, there is good visibility in this direction.
