Oil and Hazardous Materials Findings and Soil Management Recommendations

DATE: October 20, 2009
TO: Michael Cunningham, P.E., S E A
FROM: Richard K. Quateman, LSP, CHMM, S E A
CC: File
SUBJECT: Oil and Hazardous Materials Findings and Soil Management
Recommendations – CAM 400 Sewer Separation Project
S E A No.: 2008288.01-A

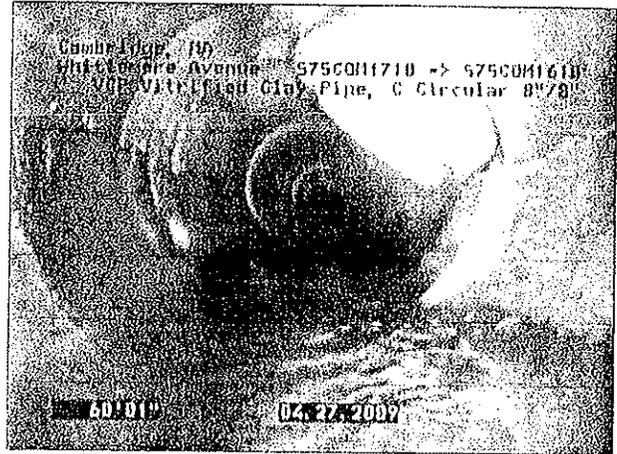
Photo: 5_12a, Tape/Media No.: T152-042709-1, 00:06:50
60.1FT, Tap Break-In Intruding, at 02 o'clock, 6", 2", 20 %,
within 8 inch: YES

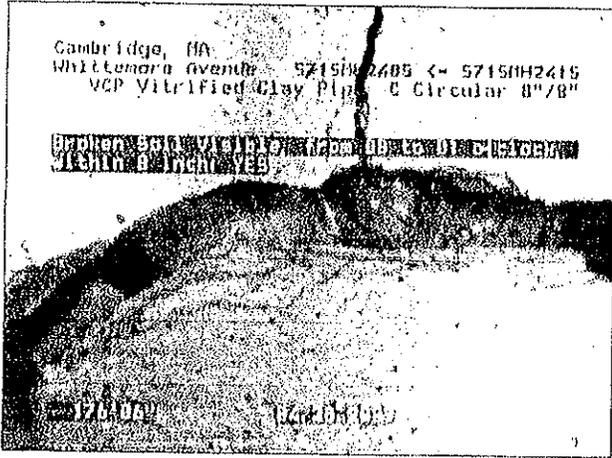
Photo: 15_15a, Tape/Media No.: T152-042809-1, 00:08:56
176.5FT, Broken Soil Visible, from 08 to 01 o'clock, within 8 inch: YES

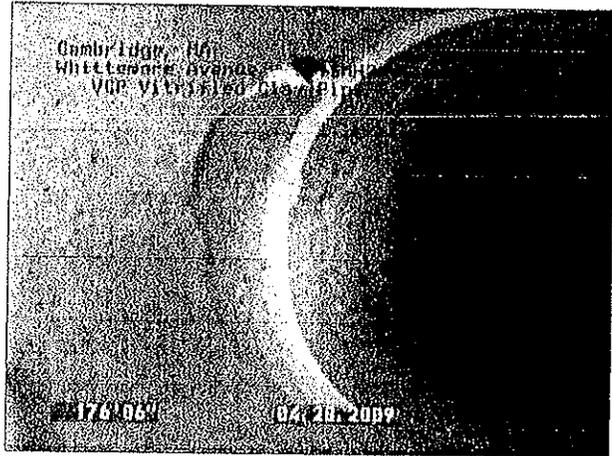
Photo: 15_15b, Tape/Media No.: T152-042809-1, 00:08:56
176.5FT, Broken Soil Visible, from 08 to 01 o'clock, within 8 inch: YES

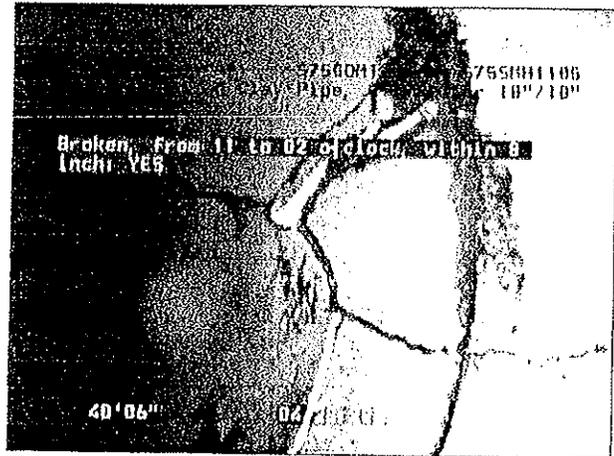
Photo: 4_8a, Tape/Media No.: T152-042809-1, 00:03:19
40.5FT, Broken, from 11 to 02 o'clock, within 8 inch: YES

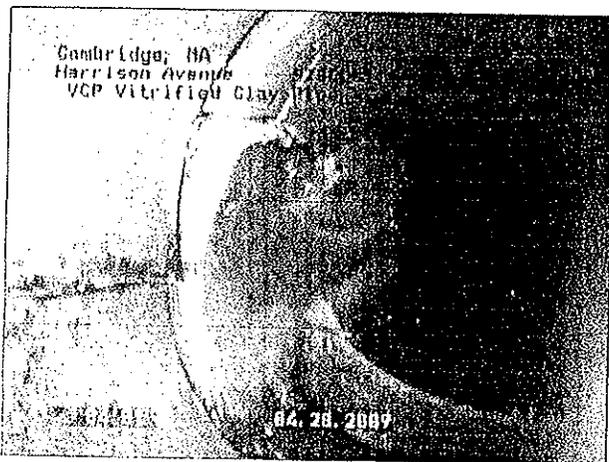
Photo: 4_13a, Tape/Media No.: T152-042809-1, 00:05:54
84.1FT, Broken, from 09 to 03 o'clock, within 8 inch: YES

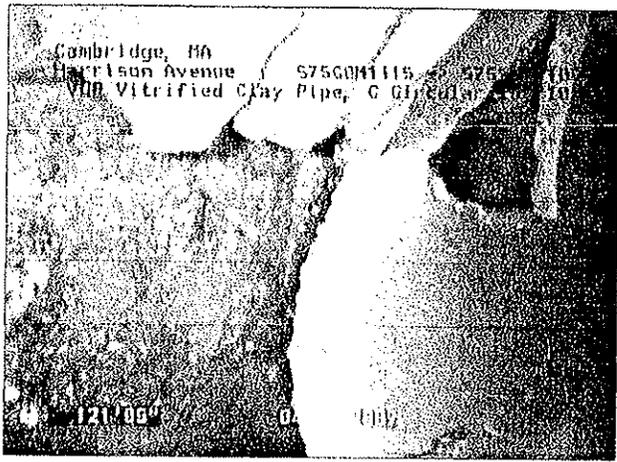
Photo: 50_20b, Tape/Media No.: T152-042809-1, 00:14:42
121.4FT, Infiltration Gusher, from 10 to 02 o'clock, within 8 inch: YES, Remark: Approx. 5+Gpm

50, 20a, b + replace seal M6

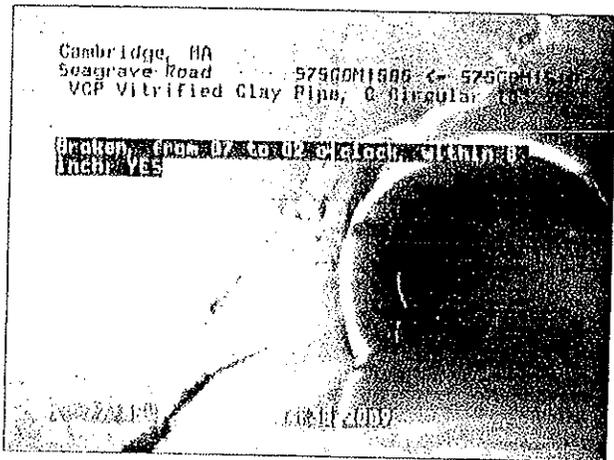
Photo: 47_5a, Tape/Media No.: T152-043009-1, 00:03:27
77.4FT, Broken, from 07 to 02 o'clock, within 8 inch: YES

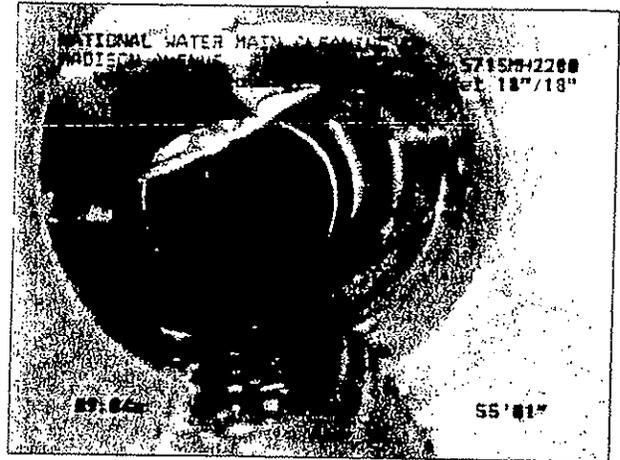
Photo: 16b, Tape/Media No.: 41-091808-1, 00:03:35
55.12FT, Broken, from 09 to 03 o'clock, within 8 Inch: YES

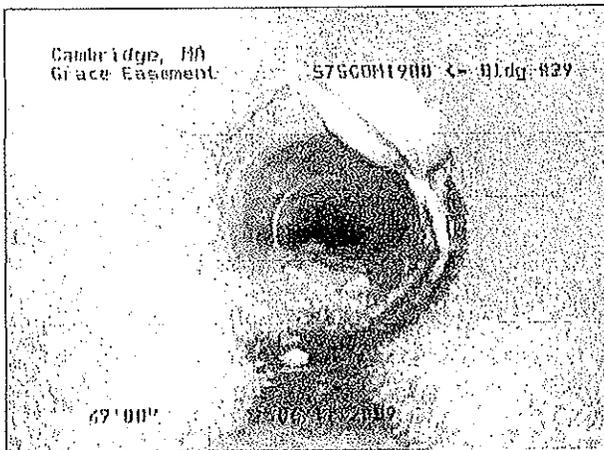
Photo: 22_5a, Tape/Media No.: T152-061109-1, 00:03:29
49FT, Tap Factory Made Intruding, at 01 o'clock, 6", 1", 10 %, within 8 inch: YES

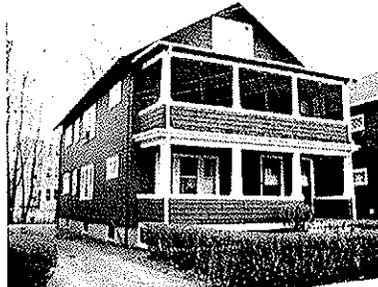
The property at 13 Harrison Avenue had a sump pump which is hard-piped to the sanitary service discharge below the basement slab. This property owner also reported seasonal flooding. Additional observations would be necessary to determine how the sump pump could be removed from the sanitary stack and redirected either to the surface outside the building or to a drain lateral in Harrison Avenue provided by the City. There is an area of grass in the backyard of the property to which the sump pump drain might be redirected.

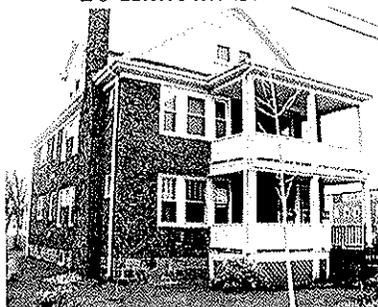
The building at 16 Kimball Street has two sump pumps which are hard piped to the buildings sanitary service. No photo is currently available, however during the inspection it was noted that the two sump pumps are connected via PVC pipe above the basement slab into the sanitary stack. It appeared as though they could be easily removed from the sanitary stack and redirected either to the surface outside the building (to an adjacent garden area north or east of the building) or to a drain lateral in Kimball Street provided by the City.

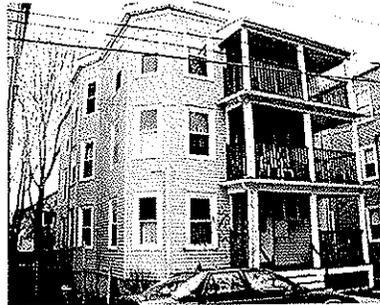
The property at 24 Madison Avenue has a sump pump hard piped to the buildings sanitary sewer stack (see Figure 1. below). The homeowner at 24 Madison Avenue reported regular seasonal flooding during which use of their sump pump is necessary. This sump pump could be easily removed from the sanitary stack and redirected either to the surface outside the building or to a drain lateral in Madison Avenue provided by the City. There is an area of grass south of the building to which the sump pump drain could be redirected.

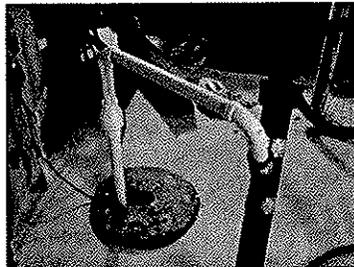
Figure 1.24 Madison Avenue

Sump pump at 24 Madison Avenue hard piped to sanitary service, easily removed and redirected to surface or drain lateral

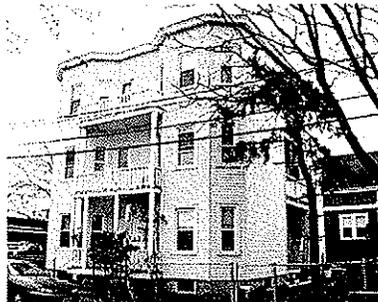
The property at 58 Madison Avenue has a roof drain that is connected externally to the sanitary stack at the rear of the building (see Figure 2. below). The property also has garden areas on either side of the building. It

therefore appears that this house would be a good candidate for removing the roof drain from the sanitary stack and hard-piping a roof drain line to either of the side garden areas or to a drain lateral provided by the City in Madison Street.

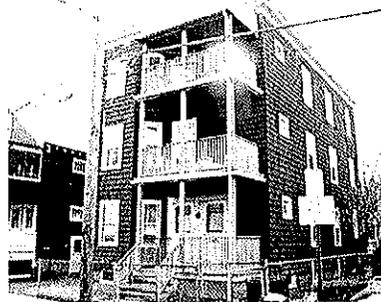
The building at 39 Magoun Street has a flat roof with an internal drain roof drain pipe hard-piped into the buildings sanitary service. The roof drain connection to the sanitary service could not be seen in the course of the inspection and therefore no photograph of this connection is available. It was determined that the connection is either outside of the foundation under a back porch or in an inaccessible area of the basement. The exact layout of this connection would have to be observed before determining if and how the roof drain could be separated from the sanitary service and redirected to either the surface outside the home or to a drain lateral in Magoun Street provided by the City. There is a garden area at the back of the home to which the drain line could be redirected.

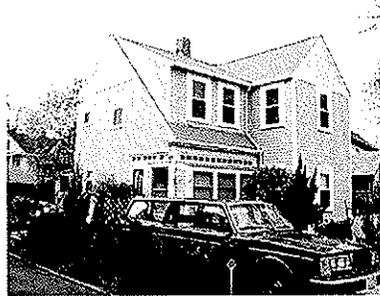
The homeowner at 15 Kassul Park reported that during heavy rains, when pumping gets severe, he will manually discharge the sump pump to the sanitary sewer cleanout. The homeowner should be encouraged to redirect their sump pump into the garden areas surrounding the house or to harp-pipe the sump pump into the storm drain (with the City providing a lateral from the proposed drain line in Kassul Park).
