**RE:** File No. 7202 –Kennedy Longfellow Roof Replacement - Addendum No. 1

Kennedy Longfellow School

Roof Replacement Project

General Roofing conditions.

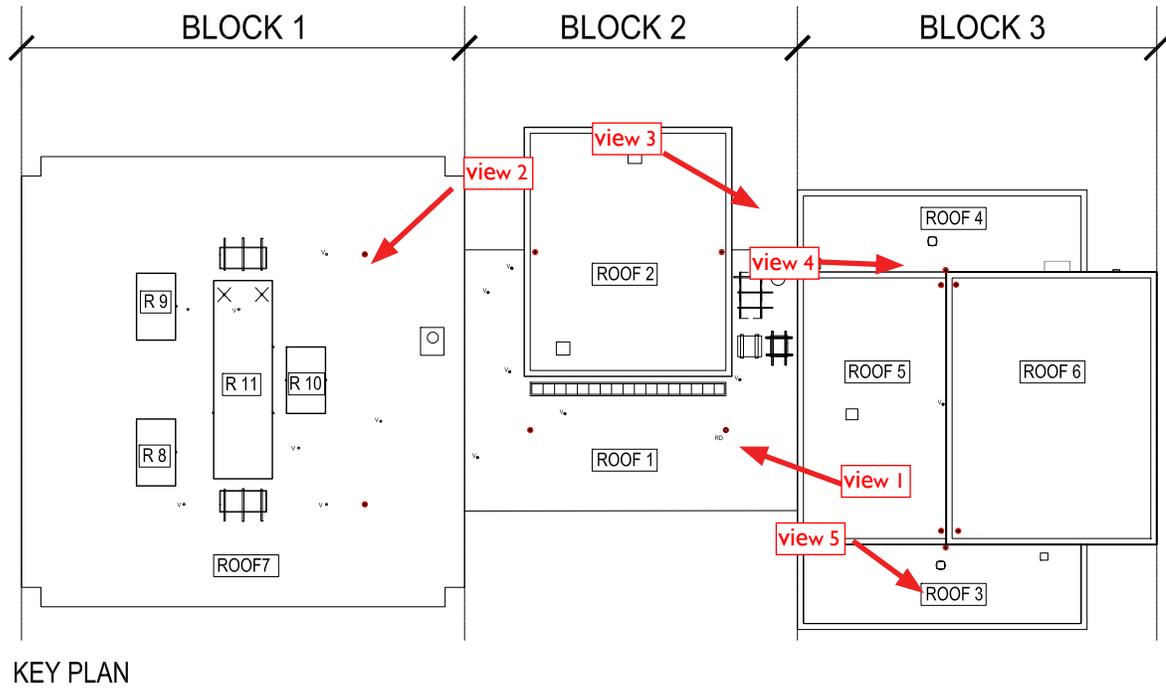
The Site of the Kennedy Longfellow School building is relatively flat and within the context of a residential neighborhood. The site encompasses almost the entire block and includes the school building, a small playground, the staff parking lot, and a city own baseball field, the John A Ahern Field.

The school is organized in three main blocks with varied roof elevations. Block 1 houses 40 classrooms and lab spaces over three floors, Block 2 houses the auditorium, administration/faculty offices, and is the main entrance for the school. Block 3 houses the cafeteria, gym, lockers, boiler room and larger gathering spaces for art and music. Block 2 and 3 are separated via an expansion joint. Within each block, the roof elevations varies with the following elevations per roof with differing edge conditions.
